Report No. FHWA/RD-80/038

STREAM CHANNEL DEGRADATION AND AGGRADATION: CAUSES AND CONSEQUENCES TO HIGHWAYS

June 1980
Interim Report

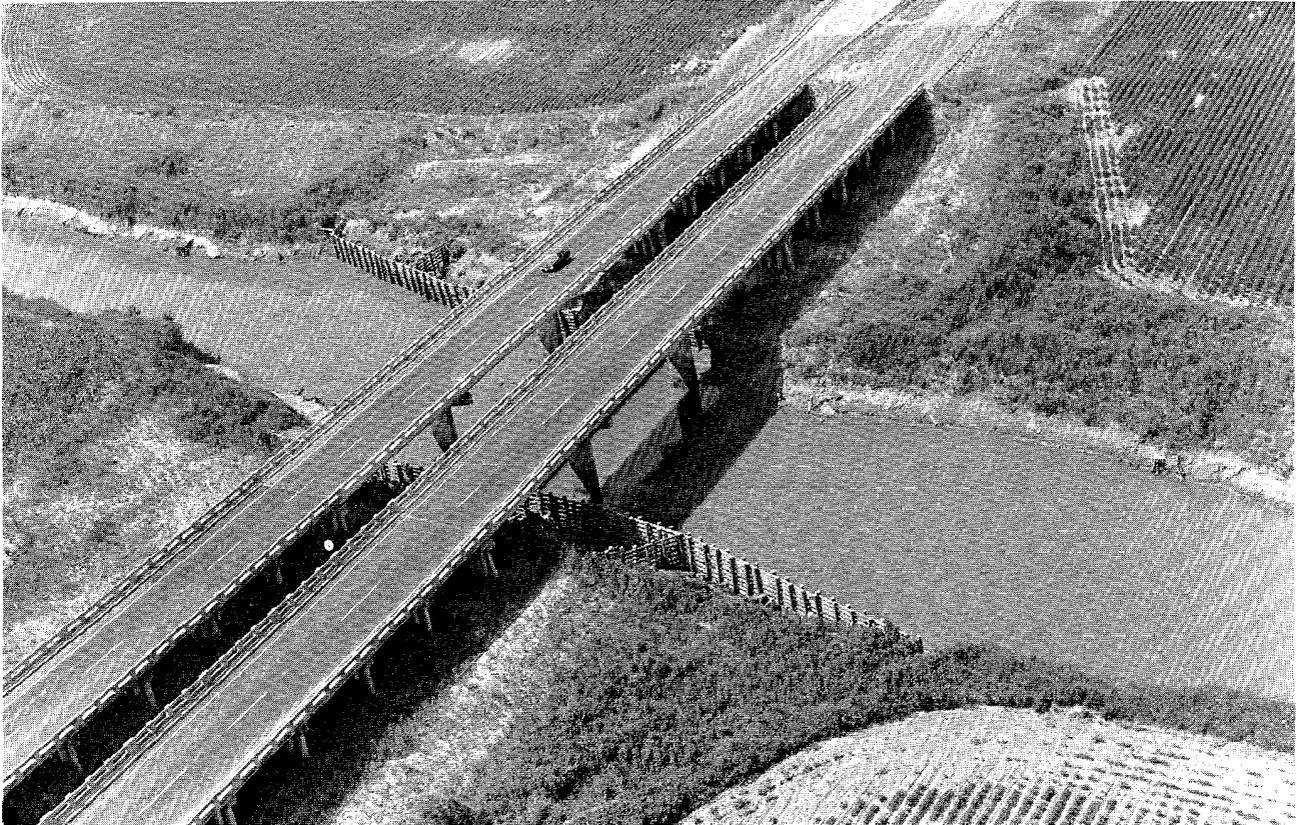
Figure 11. U.S. HIGHWAY 51 BRIDGE SHOWING TIMBER PILE RETARDS

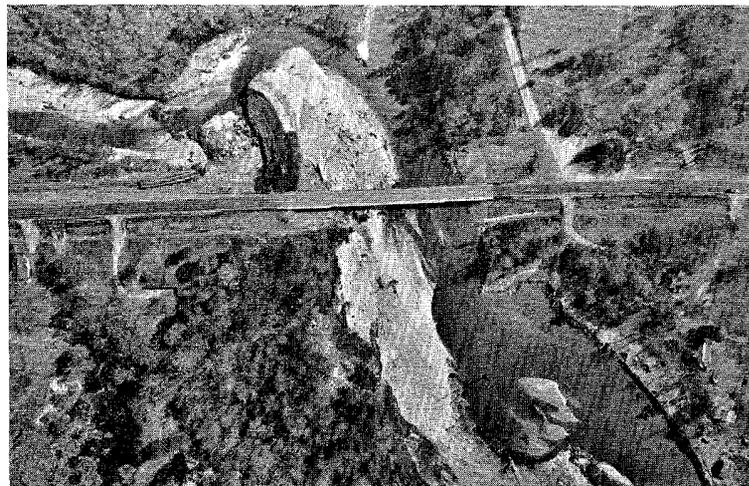
Figure 13. SR-16 BRIDGE OVER LAWRENCE CREEK NEAR
FRANKLINTON, LOUISIANA

Lateral instability of the channel is directly attributed to sand and gravel mining. Although the spur dike serves to direct flow through the bridge waterway, it does not seem to be an effective measure for protection of the approach embankment, which is subject to erosion or breaching during major floods. The main channel of Lawrence Creek is apparently too nearly parallel to the right approach embankment for the spur dike to function properly.
